University of North Carolina at Chapel Hill
Chapel Hill, North Carolina

Historic Landscape Preservation Master Plan

Existing Planting Soils Evaluation

May 12, 2008

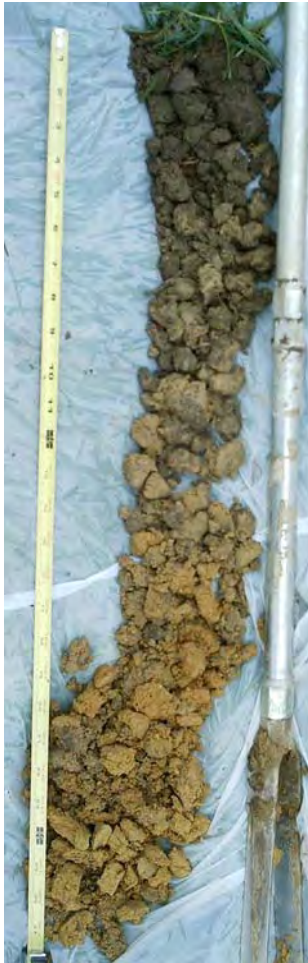
Test hole #1

Lawn

A horizon 1-5-inch. Sandy loam topsoil, well drained

B horizon 5-12 inches. Sandy Loam, soft, wet with perched water on top of hard C 1 layer

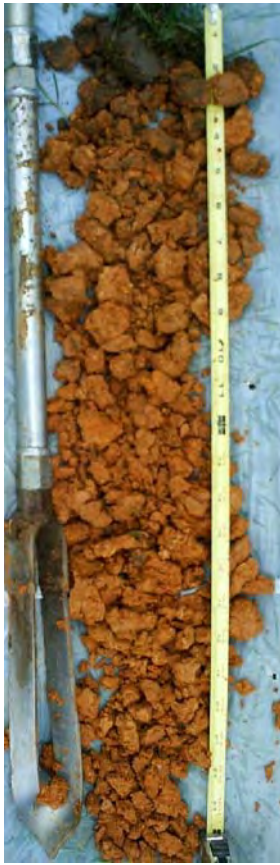
Test Hole #2
Profile

Lawn

A horizon 1-2 inch loam topsoil/sod

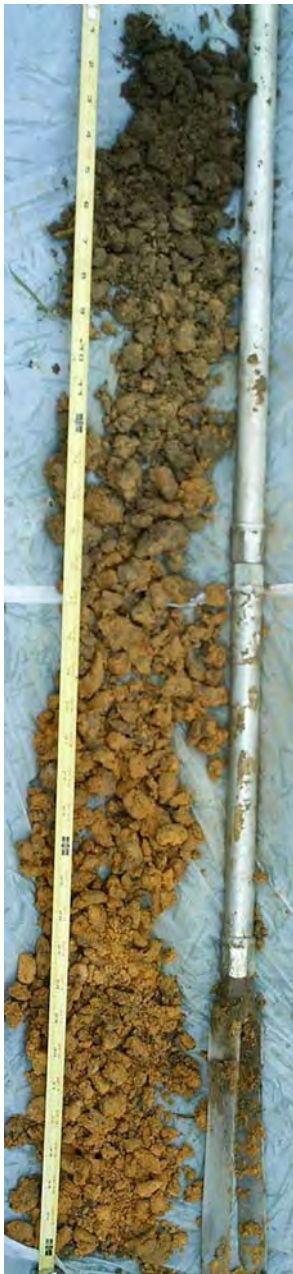
Test Hole #4
Profile

Lawn

A horizon 1-6 inch Sandy Loam topsoil

C1 horizon 15-26 inch Sandy clay loam moist but less wet that the lower portion of B above.

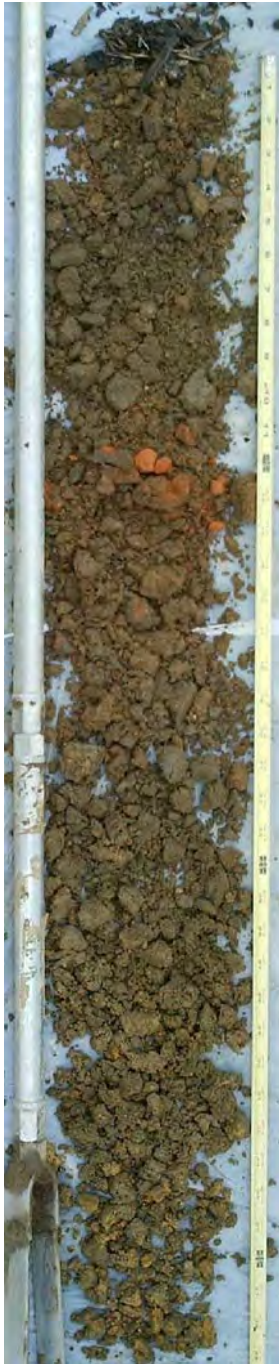
Test Hole #6
Profile

Mulch

1-5 inches A1 horizon Sandy Loam

This profile is a disturbed soil profile with fill placed over the remnant original soil. The sample was taken under the canopy of a large existing tree. The soil bulk density did not appear to be root limiting.

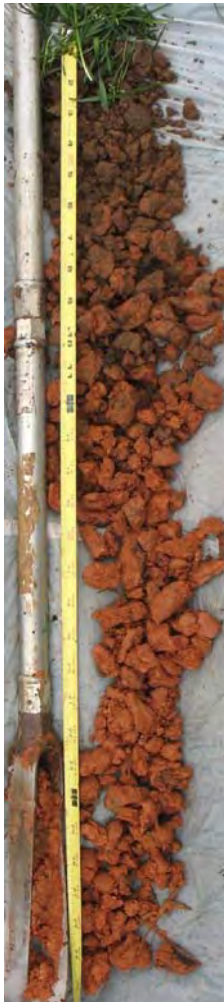
Test hole # 7
Profile

Lawn

1-5 inches A horizon loamy soil

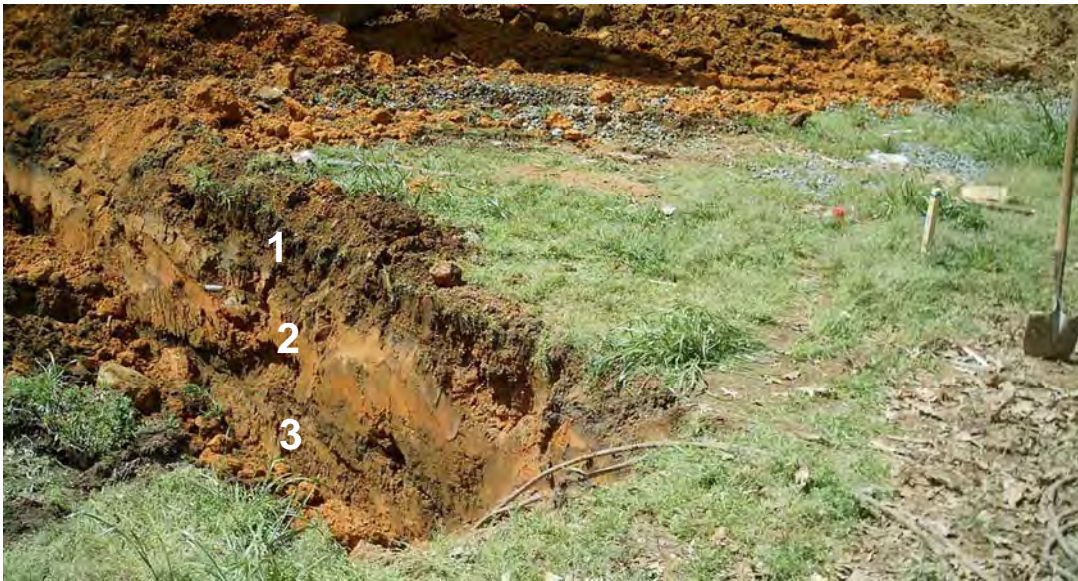
Trench at west side of Polk Place: 1. imported topsoil layer; 2. imported subsoil layer; 3. remnant original topsoil and subsoil layer.

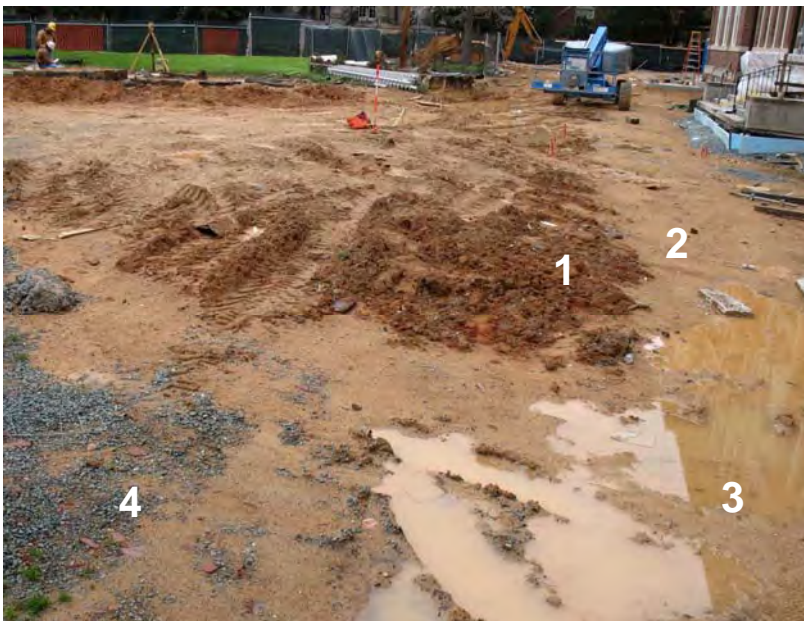
Active soil disturbance

1. Damaged soil ped structure leads to....
2. Compacted soil with all structure lost resulting in
3. Poor drainage.
4. Soils contaminated with stone and rubble.

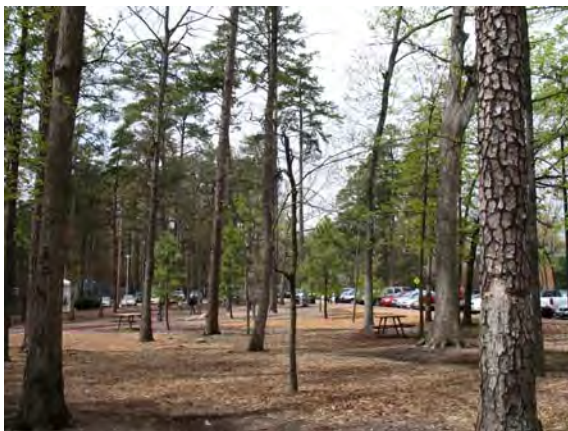
Declining forest with crusty soil and no seedling trees.

This amount of surface compaction is not great enough in this soil texture to be the sole reason for tree decline. While compaction may be a part of the problem with the declining forest, other issues such as erosion, surface crusting which slows infiltration, loss of leaf duff, other soil disturbances, and other tree stress vectors also are likely contributing to the decline of the trees.

In the declining forested areas young under story trees particularly seedling succession trees are not present. It is likely that in these declining forest areas, the large trees are not so much in decline as the natural succession of the forest has been stopped. Older trees, in competition for canopy and light continue to go through natural decline processes but are not being replaced. This is evident in the two images above. This decline is then accelerated by other factors of soil and abusive use of the space. Restarting the succession process is critical to the future success of these forested areas.

Existing conditions remediation: It is important to stabilize the soils that have lost leaf duff and have active surface soil crusting, and erosion. Applications of 4 inches of mulch combined with surface scarification or light tilling (top 1-2 inches) to reduce surface crusting is critical in areas of bare earth. Restricting access to the forested areas by fencing and improved walk configurations is needed. Changing lawn areas on the south side of the stadium to mulch should be considered.

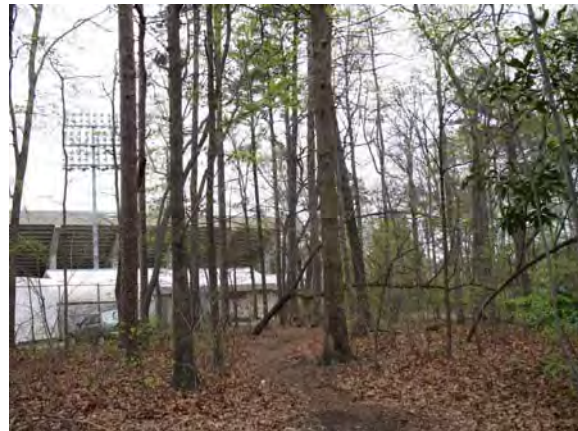
Healthy forest with leaf duff and seedling trees.

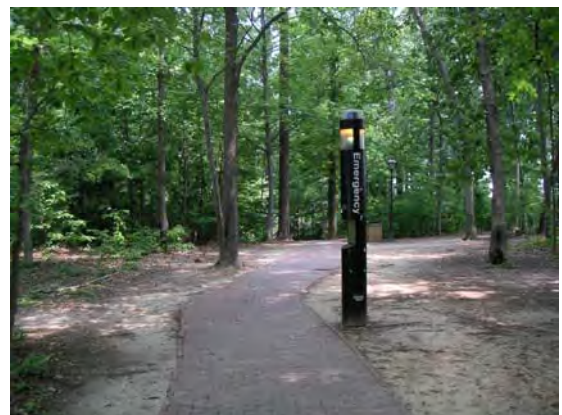
Surface erosion, crusting and compaction

In the areas where the greatest amount of compaction and surface crusting accompanies significant tree decline large scale soil invigoration combined with fences to restrict pedestrian and vehicular traffic must be considered.

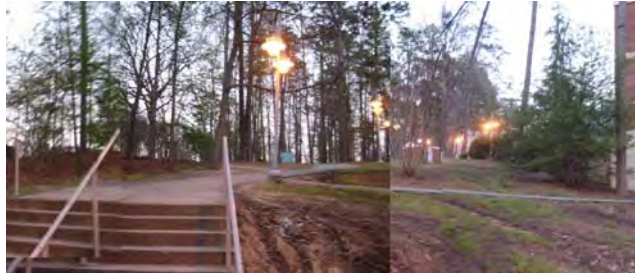
Erosion on steep bank

In areas of steep slopes and severe erosion use of stabilizing jute blankets in conjunction with the surface scarification, adding new topsoil and mulching may be required.

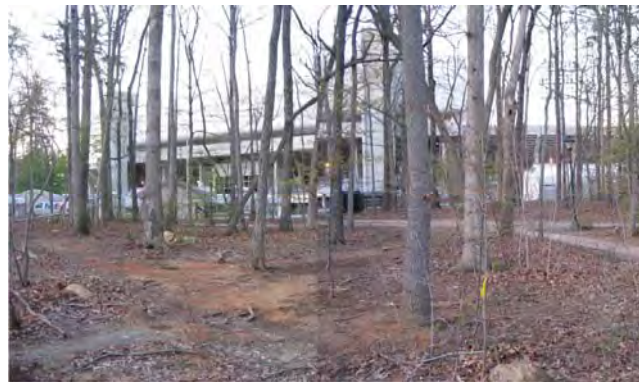
At the south edge of the woods, an area of soil has been impacted by adjacent construction. Sediment and gravel has filled over the existing soil. This must be removed, the soil scarified and mulched. Airspade soil invigoration and sediment removal techniques may be appropriate to improve this area.

Construction damage

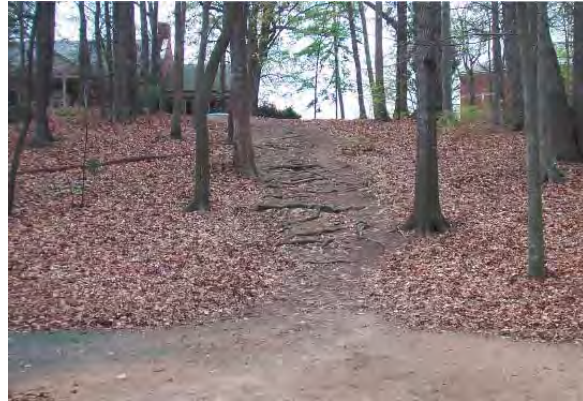
Path with leaf duff worn away, erosion, surface crusting and lack of seedling trees.

Places where there is no leaf duff, compaction, soil crusting and/or erosion should be restored by airspade soil invigoration and mulching. In eroded areas topsoil may need to be added to cover exposed roots.

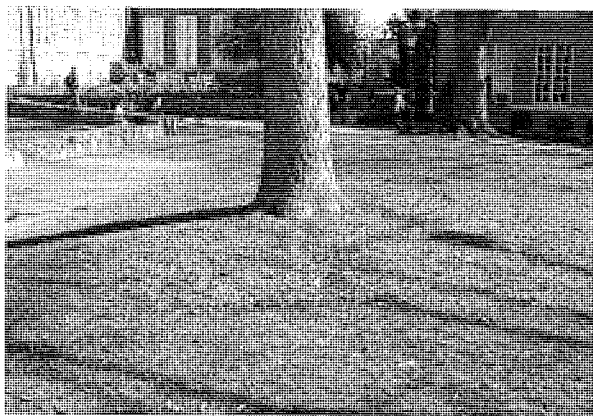
Current mulching practices have succeeded in reducing soil compaction but mulch ring

2) Mulch should be applied to all of the trees to conserve soil moisture and reduce future compaction. This treatment should be applied as soon as practical (summer 2006). The mulch area should correspond to the area that will receive

Root Invigoration next winter (radius = trunk diameter X 5). Mulch is best applied as a two inches thick layer of compost covered with a two
