UNC Chapel Hill Venable Hall Demolition recycling and waste management

Planning: June 2004 – July 2007

August 2007 - January 2008

Prepared by Sarah Myers

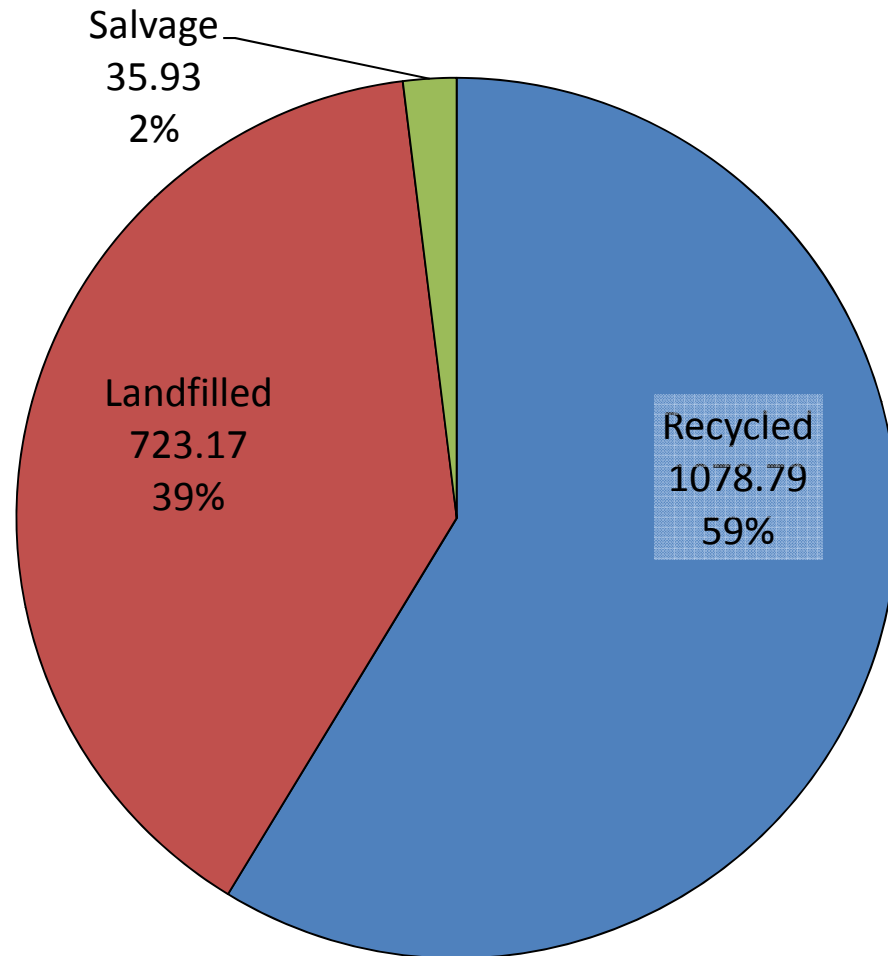
**Venable Demolition:
waste and recycling summary (in tons)**

- Total debris = 1,838 tons
- Total diversion from landfill (recycling + salvage) = 1,115 tons, **61%**
- Salvage constitutes a small percentage by weight, but relatively high value
- Includes items salvaged by IRN but not equipment or furniture salvaged by UNC shops or UNC Surplus.

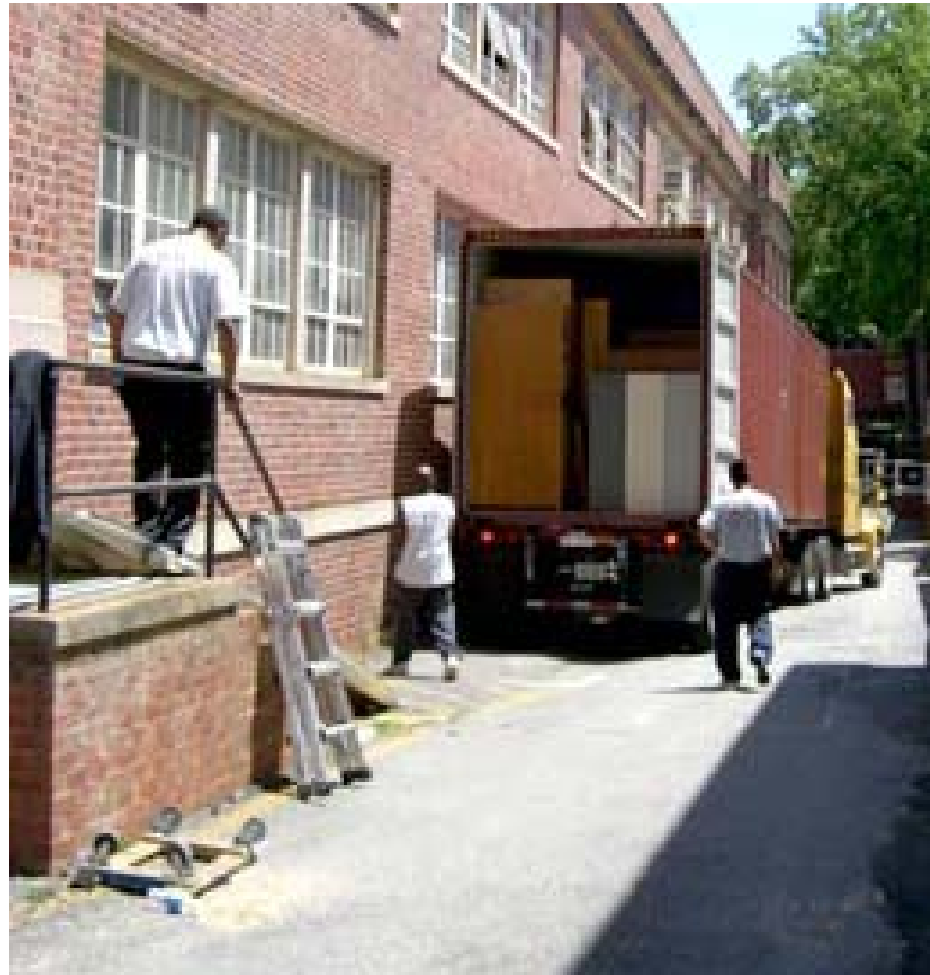
IRN furniture and fixture salvage

- Chairs, student desks, file cabinets, bookshelves, etc.
- Filled two shipping containers, estimated over eleven tons
- Loaded in two days
- Prevented roughly 7 rollofs worth of waste
- Shipped directly to Haiti under the auspices of Food for the Poor

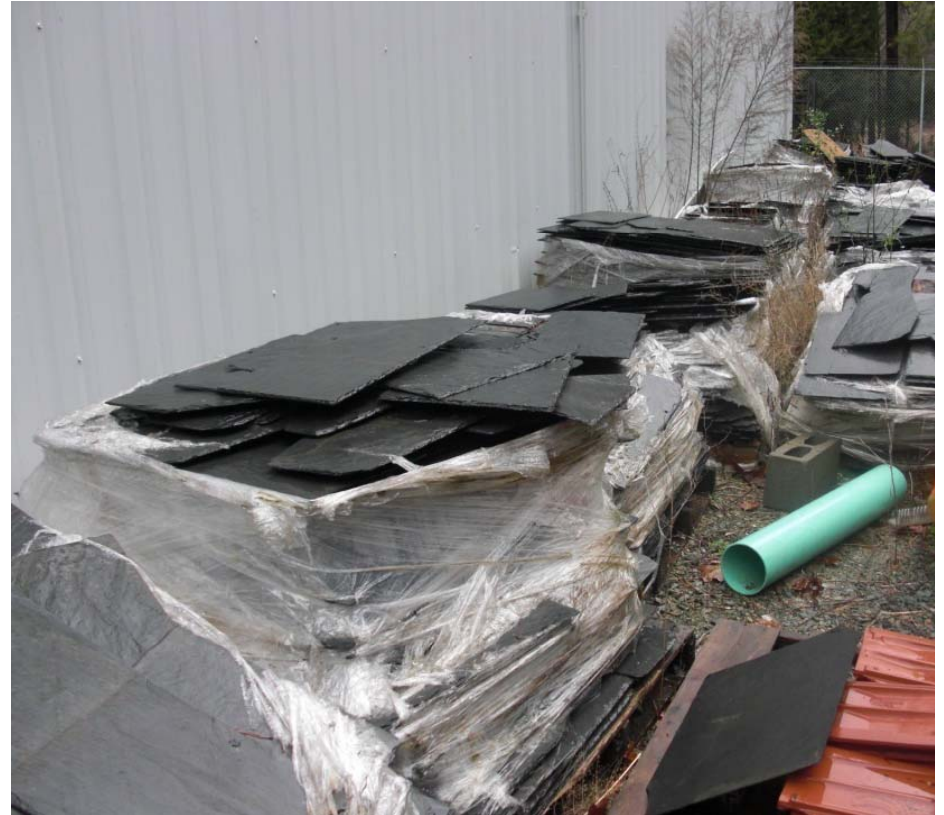
Shop salvage

- **Slate roofing tiles** - 9 squares of slate **will be reused** on a picnic pavilion
- **Steam and condensate equipment** worth about **\$5,000**
- **HVAC controls** worth about **\$5,000**

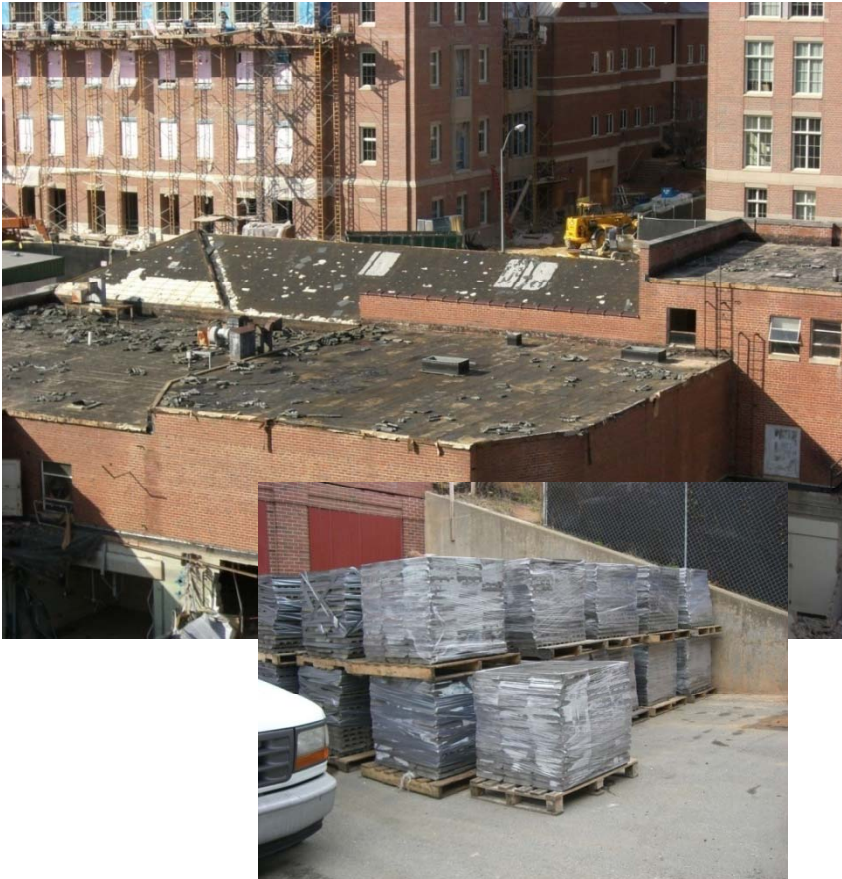
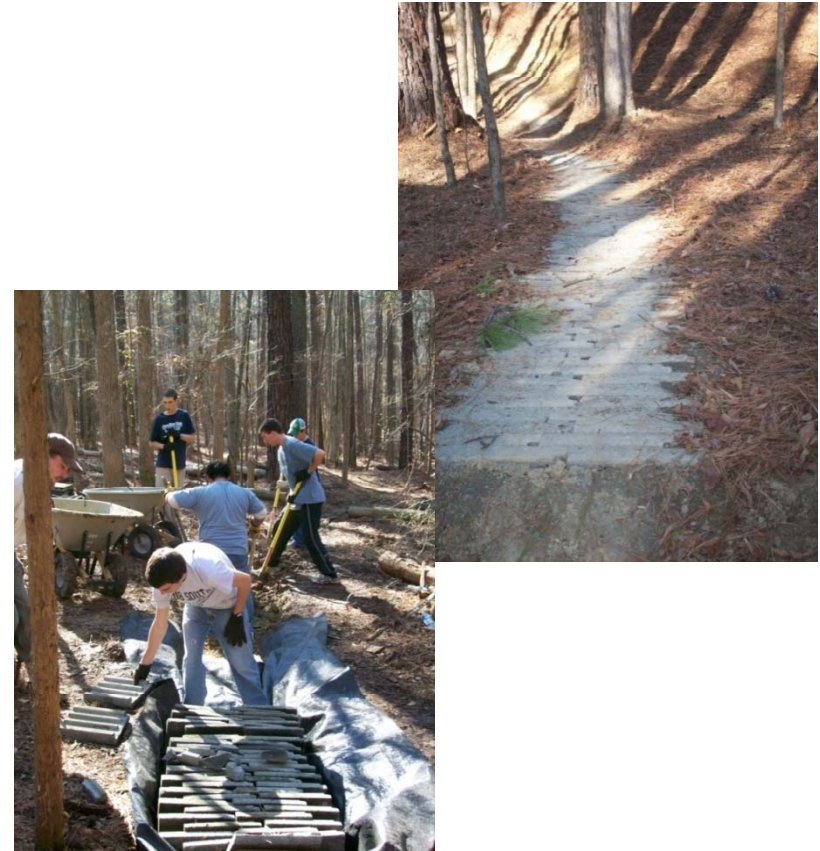
Concrete roofing tile reuse

Concrete roofing tiles were removed, put on pallets, and transported to a UNC storage area.

Carolina North Forest Staff and UNC's Cross Country & Track Club **improving muddy sections of trail** in the Carolina North Forest.

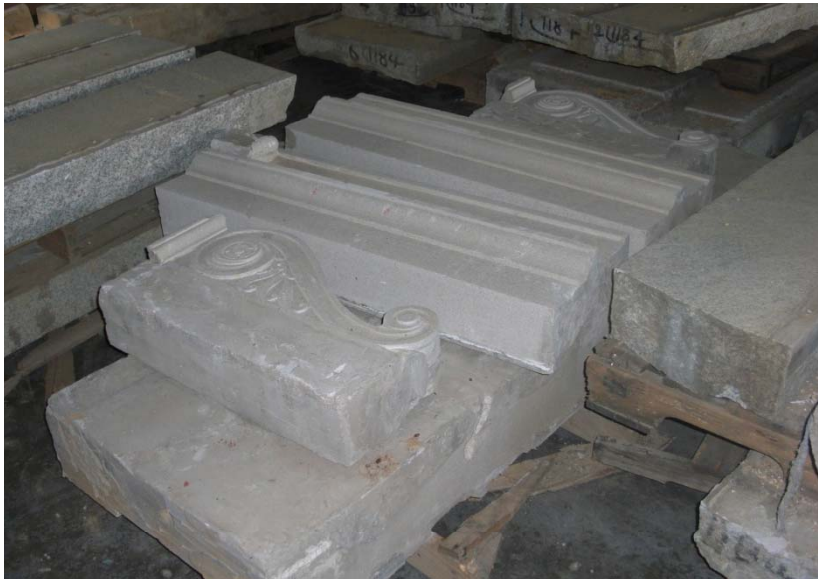
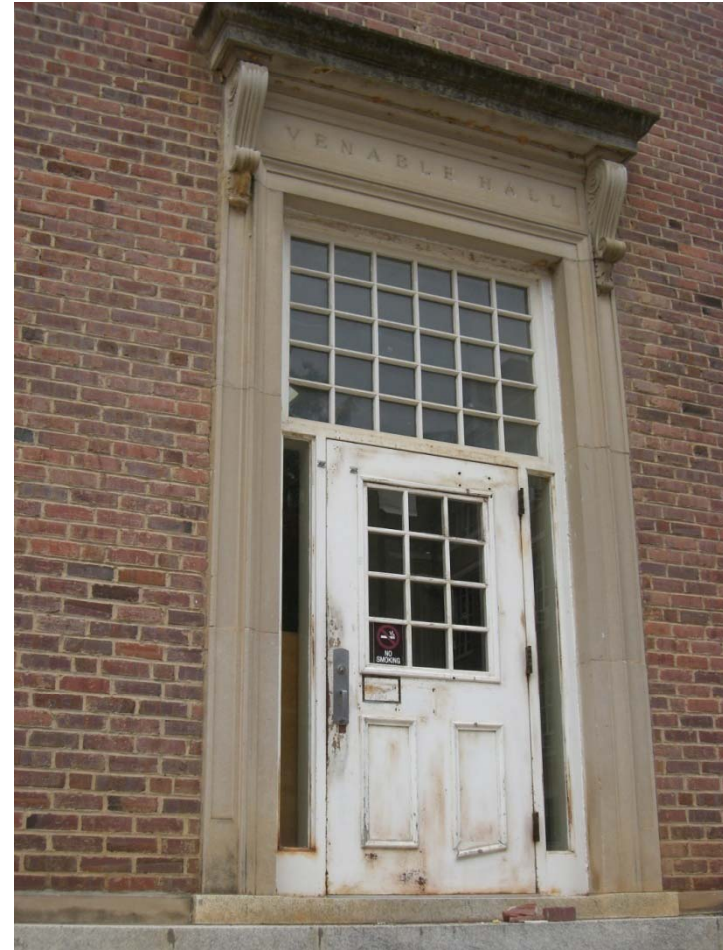
Limestone door surround

- Salvaged from Venable
- Will be **reused** in new Dental Science Building

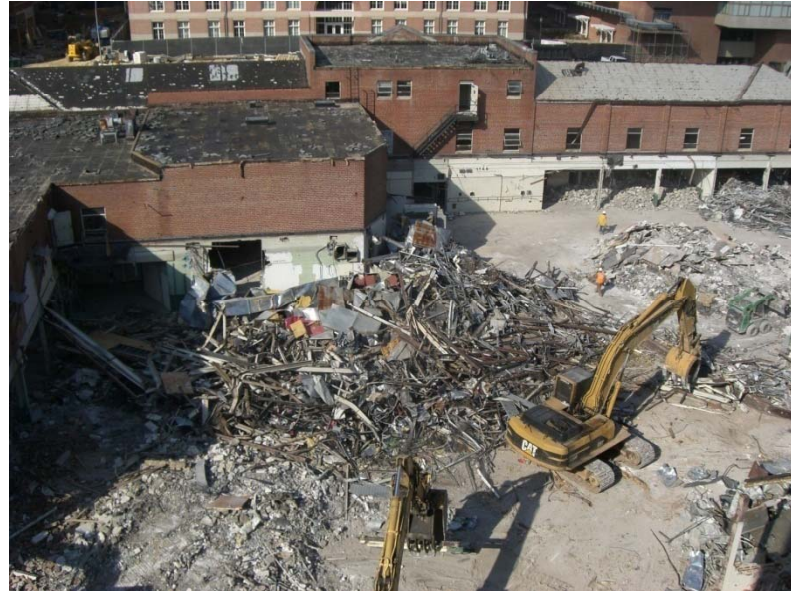
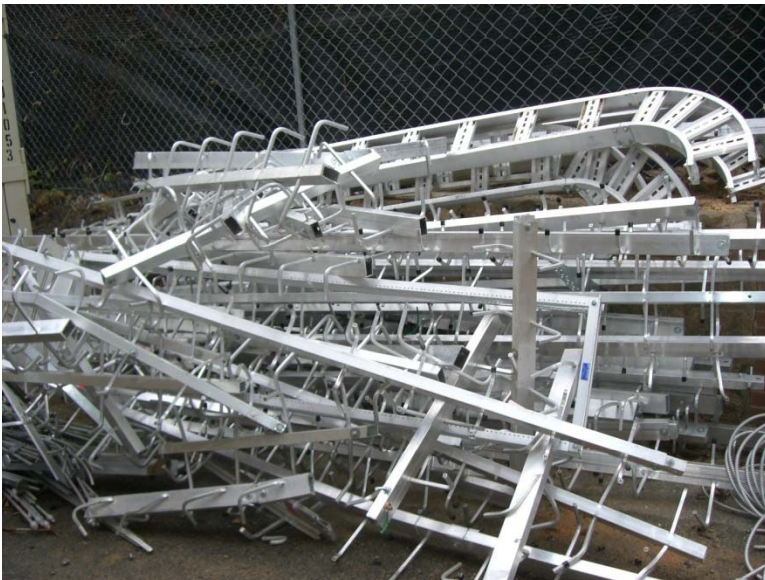
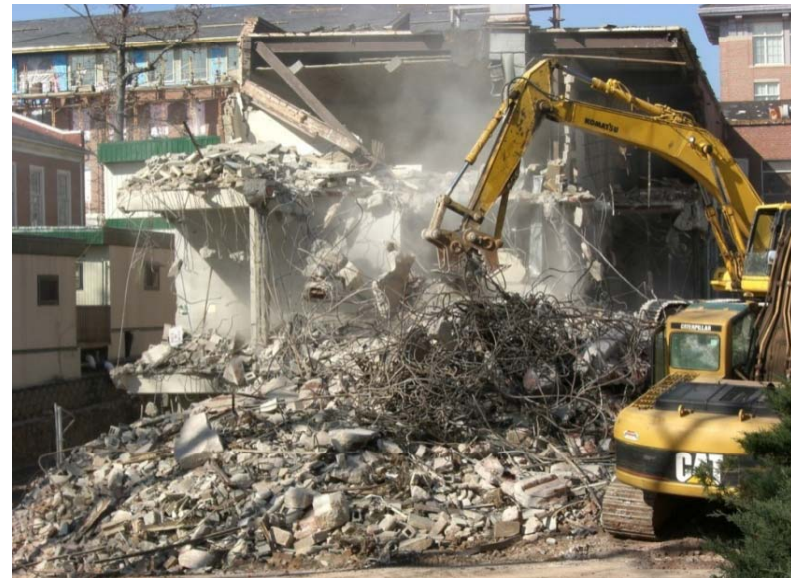
Metal – 376 tons

six different sorts for maximum value to the contractor

- galvanized
- heavy steel
- rebar
- light metal
- stainless steel
- copper

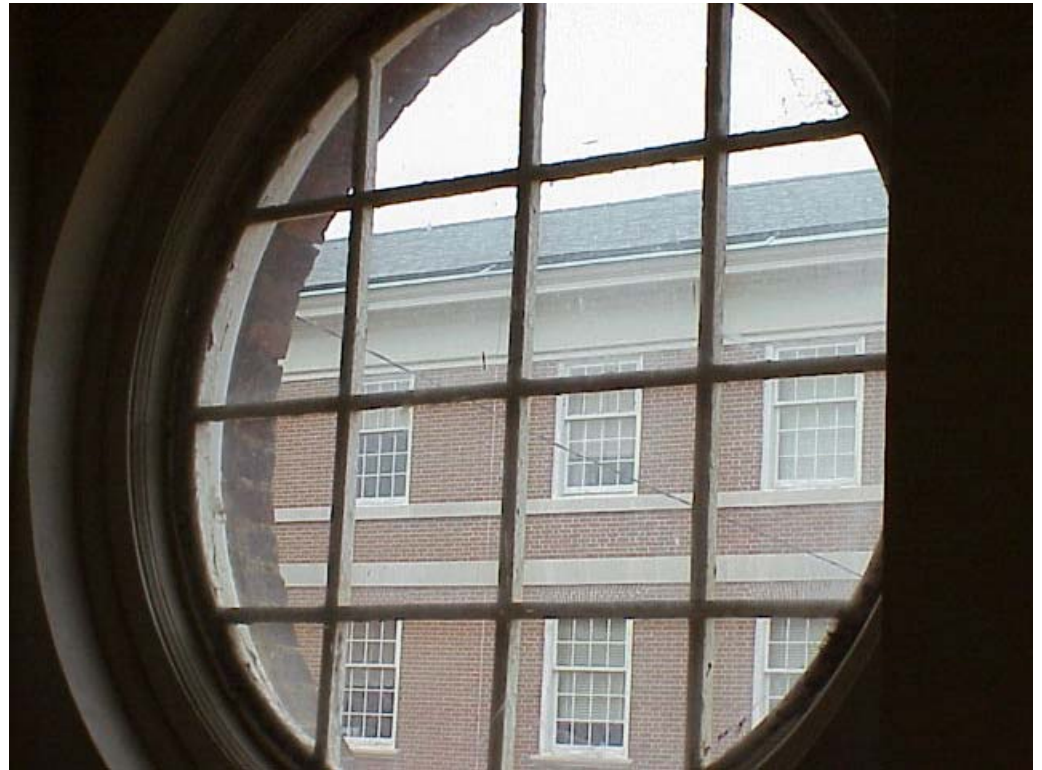
1. Hard to coordinate with outside salvage companies – **a few planned salvage items fell through**
 - Four foot circular windows (with LCP and asbestos glazing)
 - Wood shelving in library
