University of North Carolina at Chapel Hill
Chapel Hill, North Carolina

Historic Landscape Preservation Master Plan

Existing Planting Soils Evaluation

May 12, 2008

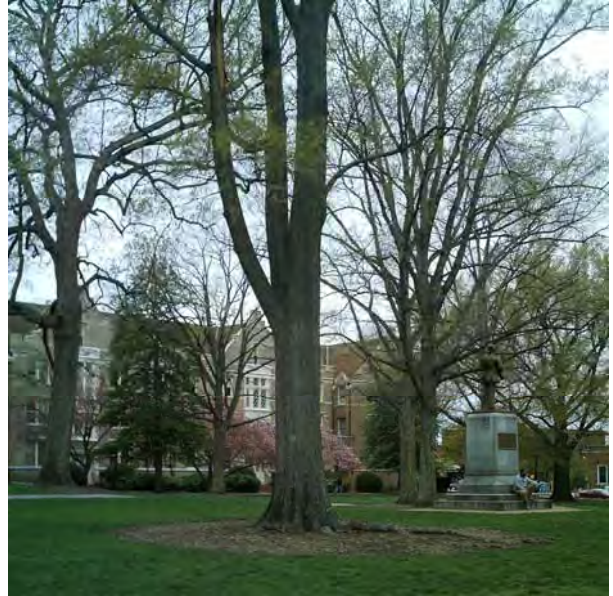
Description: This site has significant areas of original and remnant soil. The soils in the largest areas of this quad are only slightly impacted by grading. The topography is undulating and the many large and historic trees have protected the ground from utility intrusion and other development work. The buildings that edge this space are smaller and older structures that likely had limited impact on soil during their construction. Limited areas of disturbed and compacted soils were observed related to previous construction. Plants are uniformly growing well with many large mature trees.

Compaction does not appear to be a serious problem. Even the south end of the space where there is frequent pickup games and student gatherings was still just under root limiting in the upper soil profile with less compaction below that elevation.

Existing conditions remediation: No changes to the soil are recommended. Surface core aeration to alleviate surface compaction as a part of the normal lawn maintenance should be sufficient. Compaction levels in areas of heavy use should be monitored and air spade root invigoration (see appendix) should be considered if compaction increases above root limiting levels.

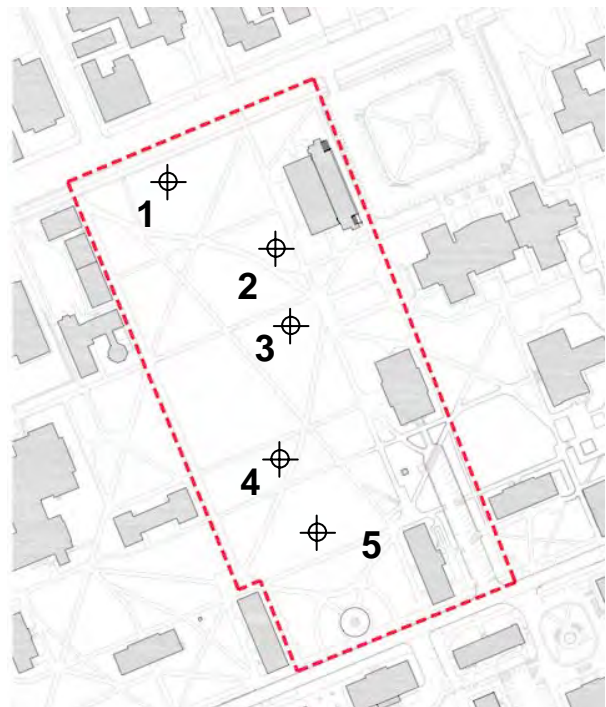
McCorkle Place test hole locations

Soil observations and testing: Five test holes were dug in the area of McCorkle Place. 5 soil samples were kept from three of the test pits and two bulk density cores were extracted. Several other test holes were dug but not recorded as they were similar to nearby recorded holes and served to verify that the recorded information was taken at a typical site.

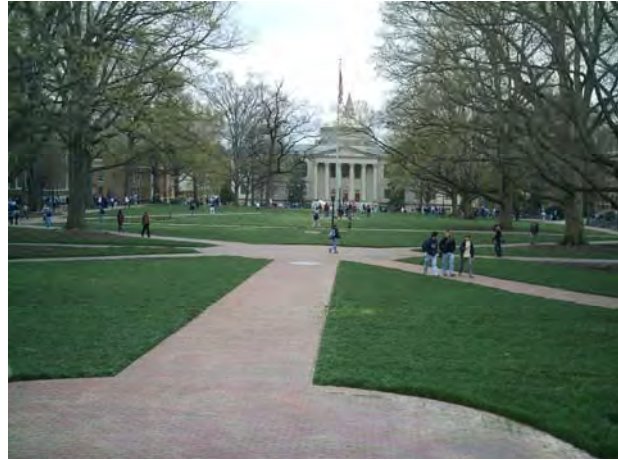
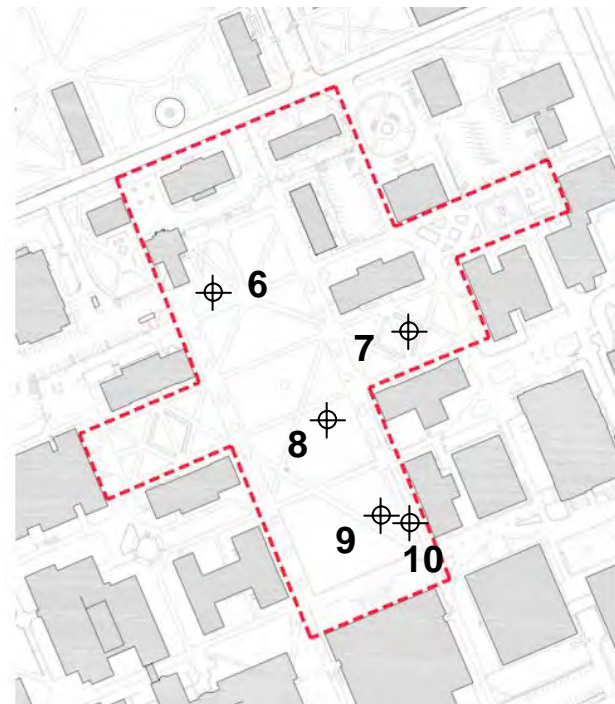
Polk Place Test Hole locations

Description: The soils in the Polk Place Quadrangle are highly disturbed. Many of the buildings, site work projects and utility development of this space occurred after the time when large construction equipment was available and there has been significant soil disturbance. Mass grading, utilities and building work has graded and compacted the soil. Multiple human constructed soil horizons and sharp, distinct soil horizons were observed. Remnant soil horizons including buried topsoil layers are found throughout the space. The soil quality appears to get worse the further south and west in the space. This is reflected in the tree growth and decline.

Soil compaction of differing amounts and different from horizon to horizon was encountered indicating fill and disturbed conditions. Compaction was noted in many locations in the Bartlett compaction study as a significant impact on tree health.

There is a strong relationship between the ages of the various buildings that front onto the quad and the health of the trees near these buildings. The older the building, the healthier the trees. This is particularly evident in the south west portion of the quad where buildings were constructed after 1940. Trees near recent utility work are also in decline

Existing conditions remediation: The Bartlett Report found significant compaction in the areas outside the drip lines of the large trees and moderate amounts of compaction in the turf areas at or within the drip lines of trees. The soil in mulched areas at the base of the trees was acceptable. The report recommended root invigoration within the limited areas around the tree, typically a radius of five times the trunk diameter. Root invigoration uses an air spade to incorporate organic matter and fertilizer into this zone while reducing compaction. Additional fertilizer treatments were also recommended based on soil testing results. These recommendations are appropriate and the campus has begun to implement these recommendations.

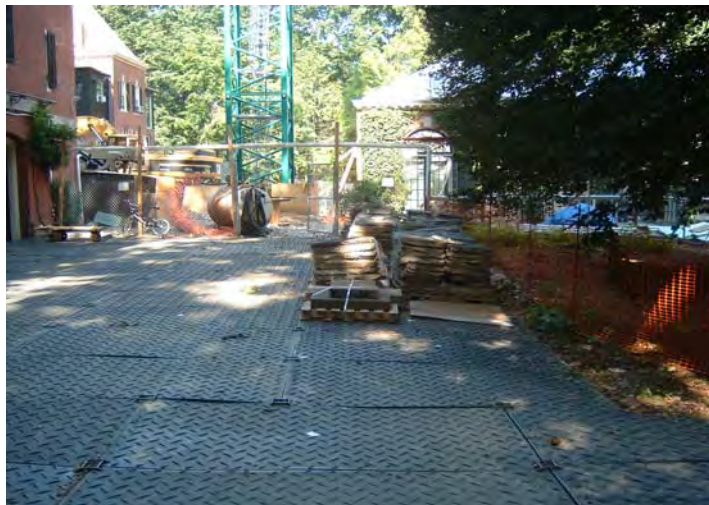
Alturnamats protecting soil

An alternative to zoning the quad would be to treat the entire quad as a soil protection zone and develop strategies that can be implemented in a cost effective way to protect the soil of the entire quad from compaction. This would include the use of geogrid and geotextile mats that could be purchased once and reused for each event. This material is relatively easy to install on a temporary basis and could cover the entire area of the quad. This matting would then be reinforced with alturnamats in the areas of the most

intense use such as tents and main walking spaces. The alturnamats are light enough and easy enough to install to be practical for repeated use.

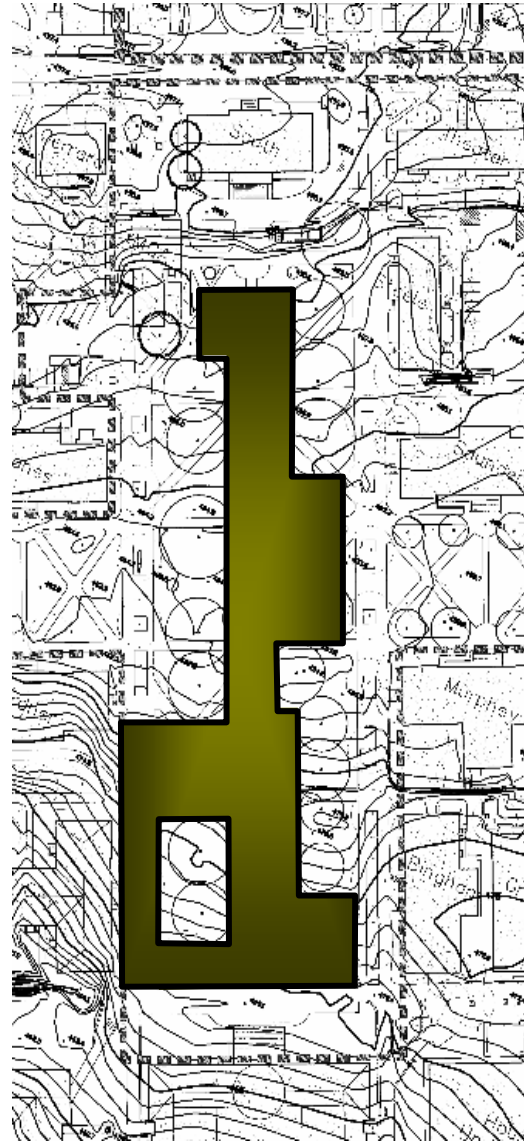
Area to consider creation of impact resistant lawn soil over Silva Cell tree

Tree / event conflict: The quad may benefit from developing a new soils direction that permits the quad to be used for intensive activities while maintaining good lawn quality and develop long term healthy trees. It is possible through the use of a newly developed structural support system called Silva Cells to have a very compaction resistant lawn soil over the top of a natural profile of native soil that supports large tree growth. The natural soil within the Silva Cells would have low levels of compaction and be protected from further compaction by the Silva Cell. The details of such an approach need to respect the existing utility network. The Silva Cell system could also be extended under walks and in areas where the subsoils are compacted above root limiting levels. In areas where the trees are growing well, making changes to the soil is not recommended.

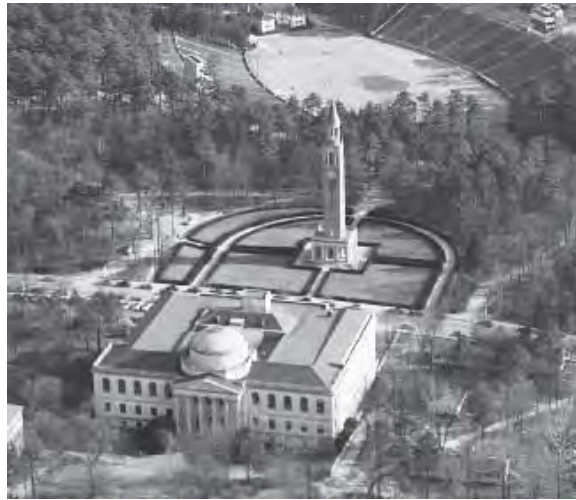
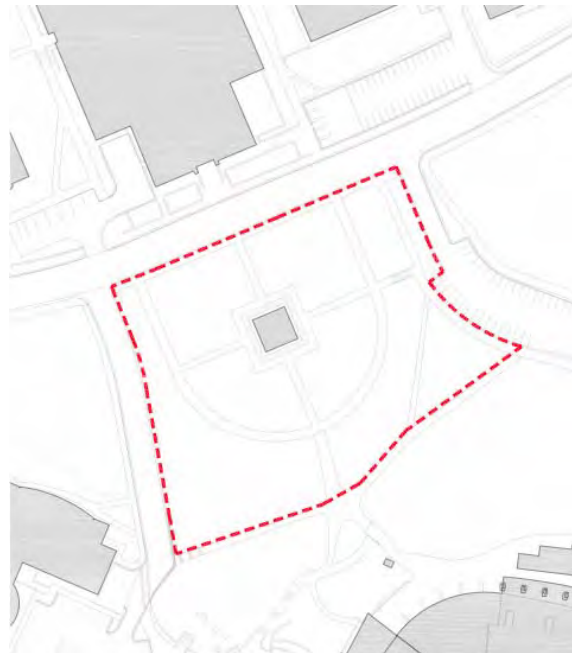
Bell Tower Formal garden

Description: The soils around the Bell Tower within the formal garden are disturbed soils, which are supporting the boxwood and lawn planting in reasonable condition. The few places where the boxwood are not growing well in the interior of the space are likely due to damage during events and other activities. One section of box along the southern portion of the outer edge of the planting seems to be declining due to differences in soil. Should this row of box be retained, soil improvement for these plants would be recommended to make the soil in this area similar to the adjacent soils.

Existing conditions remediation: Should the outer row of box be retained, minor changes to soil should be made in the south edge of this planting. Box should be removed and the soil changed to match the texture of the adjacent soils. This area is quite limited in area. No other changes are recommended

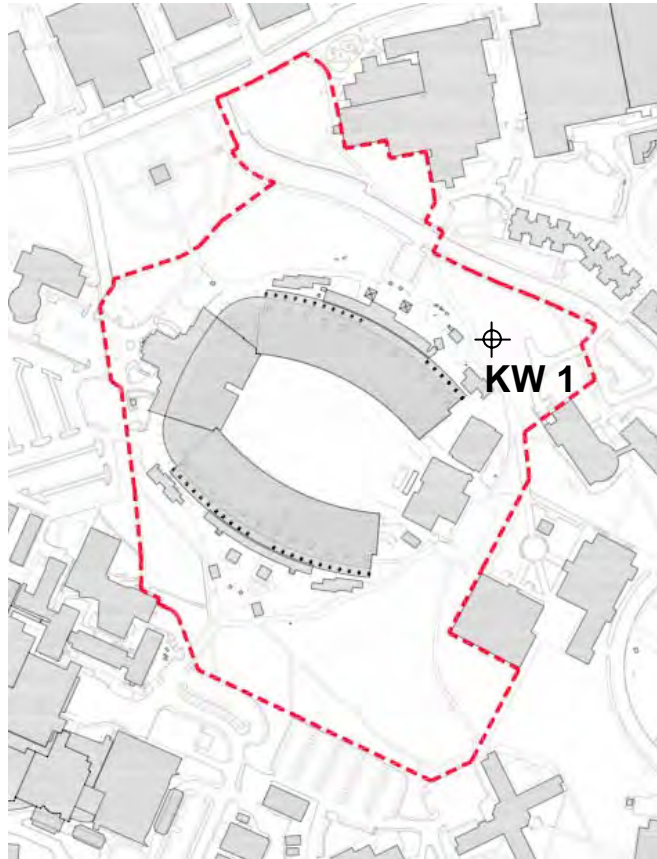
Kenan Stadium Woods

On the North side of the stadium there are two sections of woods bisected with a diagonal walk. On the south side of this walk there has been minimum amounts of disturbance. While the north side has been impacted by utility work, grading and compaction from event use associated with football games.

On the south side of the stadium the soil disturbance has been much greater with considerable grading and associated with walks and roads. Surface compaction is pervasive. Once past the southeast corner of the stadium the soil conditions to the south improve dramatically. On the east and west ends of the stadium, all soil is disturbed with considerable grading, steep slopes, erosion, paving and compaction.

Existing conditions remediation: It is important to stabilize the soils that have lost leaf duff and have active surface soil crusting, and erosion. Applications of 4 inches of mulch combined with surface scarification or light tilling (top 1-2 inches) to reduce surface crusting is critical in areas of bare earth. Restricting access to the forested areas by fencing and improved walk configurations is needed. Changing lawn areas on the south side of the stadium to mulch should be considered.

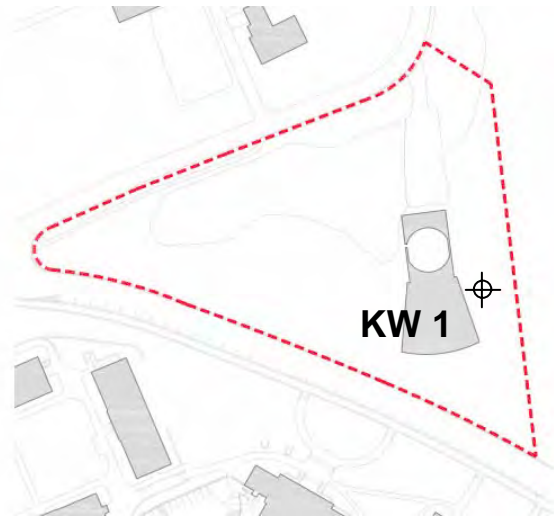
Forest Theater site

The majority of the soils in the area around the Forest Theater are undisturbed. The theater was built into the existing topography and little grading was required. It is likely that the soil between the back side of the stone edging of the seats and the front side of the next row of seats would support good tree growth once the tree reached the remnant soil layers below. Considerable surface rooting, from tree around the theater, was observed in this soil.

The stage surface has supported large trees indicating reasonable remnant soil below the crusted surface. Even the parking lot behind the theater would likely support large trees at its perimeter.

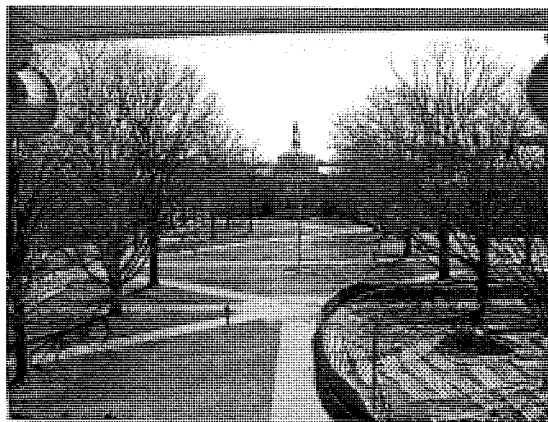
From initial discussions with campus administrators and University arborists, we learned that the trees on Polk Place have been declining and dying at an increasing rate over the past few years. This is a key location on campus both from a student use perspective and an aesthetic perspective. The trees that line the area are an integral part of Polk Place. Their loss would profoundly alter the experience of the area.

One hypothesis for the decline of the trees is that the high use of the area is causing soil compaction that limits the root growth of the trees. If this is indeed the case, examining the bulk density of the soil and the pattern of bulk density differences could confirm this diagnosis. To achieve that end, soil samples were collected to determine the bulk density of the soil in and around this area.
